Università della Calabria

**Dottorato di Ricerca in
Scienze e Ingegneria dell'Ambiente, delle Costruzioni e dell'Energia**

**Definition and application of methodological
protocols for the conservation and protection of
Cultural Heritage: case studies**

In Chapter 1 and Chapter 2, two of the most important building of the Calabrian region (South Italy), from an historical point of view, were studied: the Cosenza Cathedral, UNESCO World Heritage Site since 12 October 2011, and the Gerace Cathedral, declared Architectural Heritage of National Interest. In order to assess the different decay phenomena occurred on the building, a multidisciplinary approach has been applied, involving the combined usage of nondestructive techniques (NDTs) and microdestructive techniques (MDTs). In both cases, the same approach (with different methodologies) has been applied:

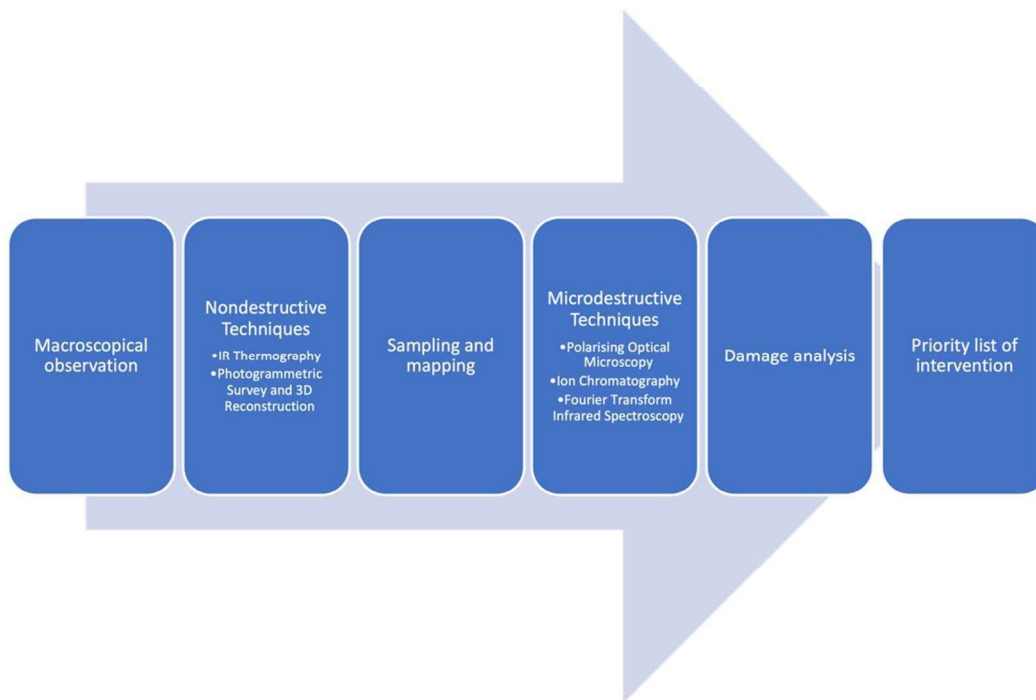
Figure 2. Workflow of the process carried out.

Next, the samples were analyzed via POM, IC and FTIR, in order to characterize qualitatively and quantitatively the different decay forms encountered. Subsequently, their detailed mapping and damage analysis were realized carrying out a photogrammetric survey (Figure 2).

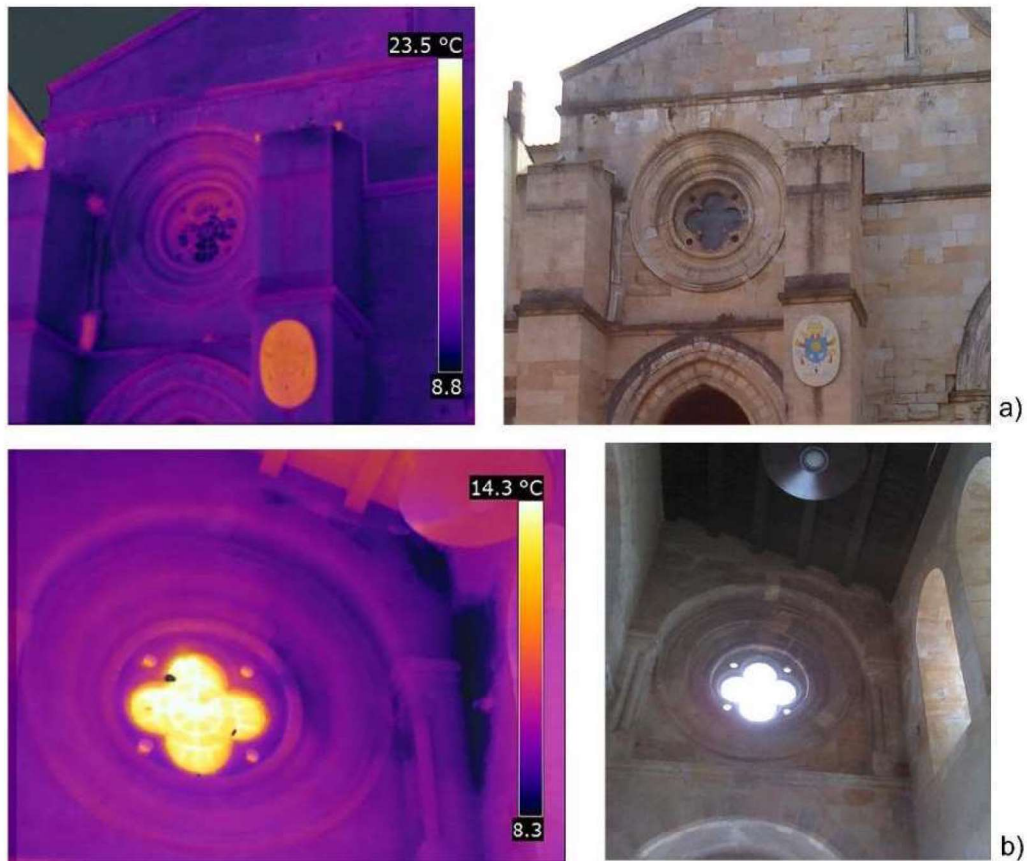
Figure 3. Thermograms acquired on the external side (a) and on the corresponding internal side (b) and comparison with the photographic images of the same areas investigated. The colder areas (blue tones) locate the infiltration at the height of the side rose. A temperature of 12.7 °C and 64% relative humidity values measured during the 23 February 2021 in situ morning session were used to postprocess the thermograms here reported. This portion of the facade of the cathedral is related to an infiltration of rainwater from the external side of the masonry or from the roof and extends up to the frames of the rose window.

In particular, at the lower parts of the external side, thermal anomalies associated with capillary rising phenomena were observed.

In the upper part, thermal anomalies compromising the structural proprieties and aesthetic values of the wall structures of the façade were detected. As clearly revealed in Figure 3, indeed, at the height of the lateral rose window, a wide water infiltration affects a large part of the façade.

Correspondingly, on the internal side, the IRT inspection documented the higher intensity signal due to a presence of rainwater in the same portion of the wall structure. The diagnostic evidence confirmed that the rainwater infiltration through damage to the roofing system is one of the causes of the major deterioration in this wall portion.

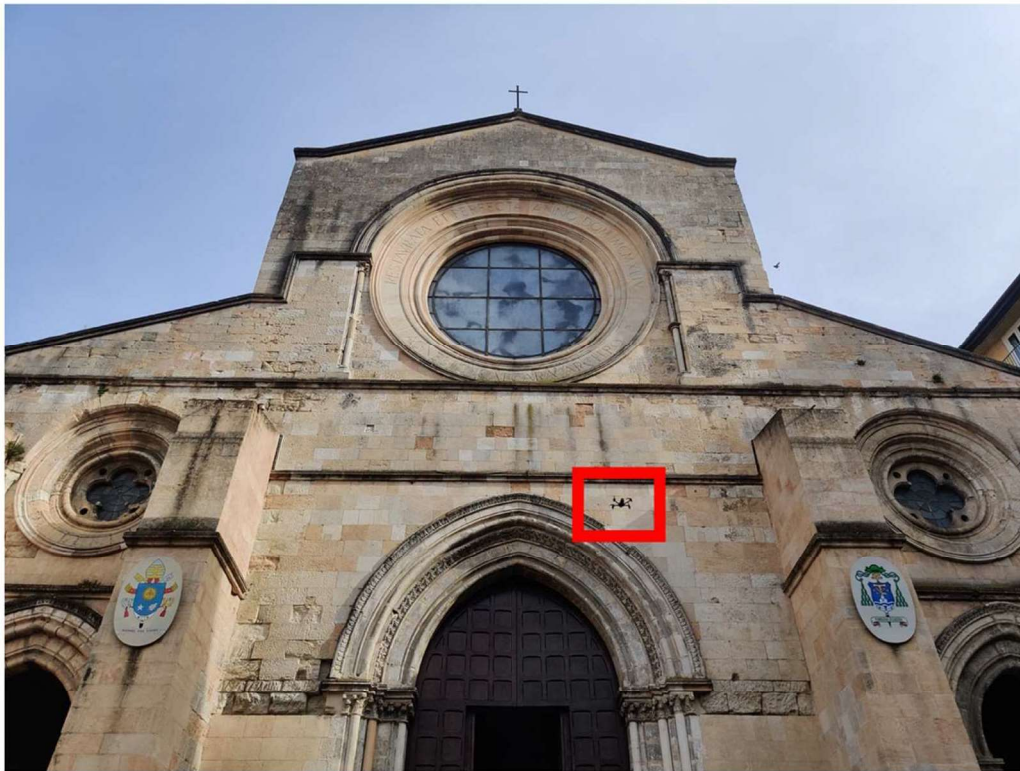
Figure 4. Detail of photogrammetric survey.

The photogrammetric survey was carried out by a drone (Figure 4) and the subsequent data processing was realized by software as Meshlab (www.meshlab.net accessed on 15 July 2021), to generate a 3D mesh, and AutoCAD, to estimate the degraded areas.

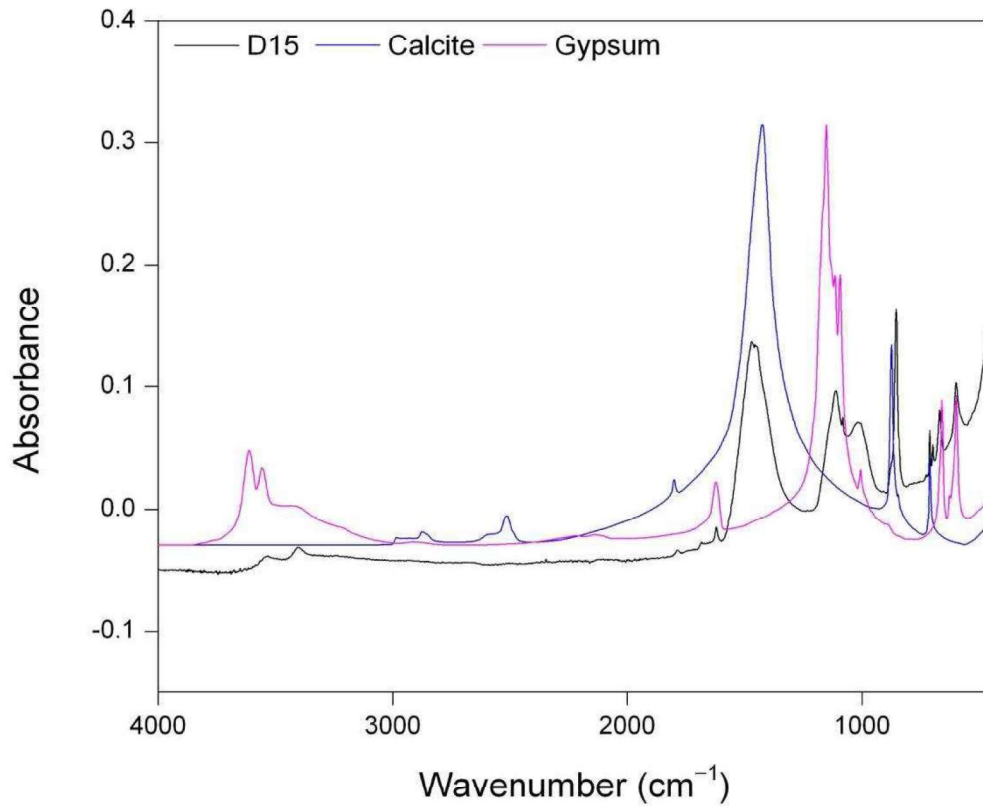
Figure 9. D15 sample IR spectra.

From the study of vibrational bands via FTIR, many mineralogical phases were identified, such as gypsum and calcite (Figure 9); moreover, traces of silicates were found (Table 6).

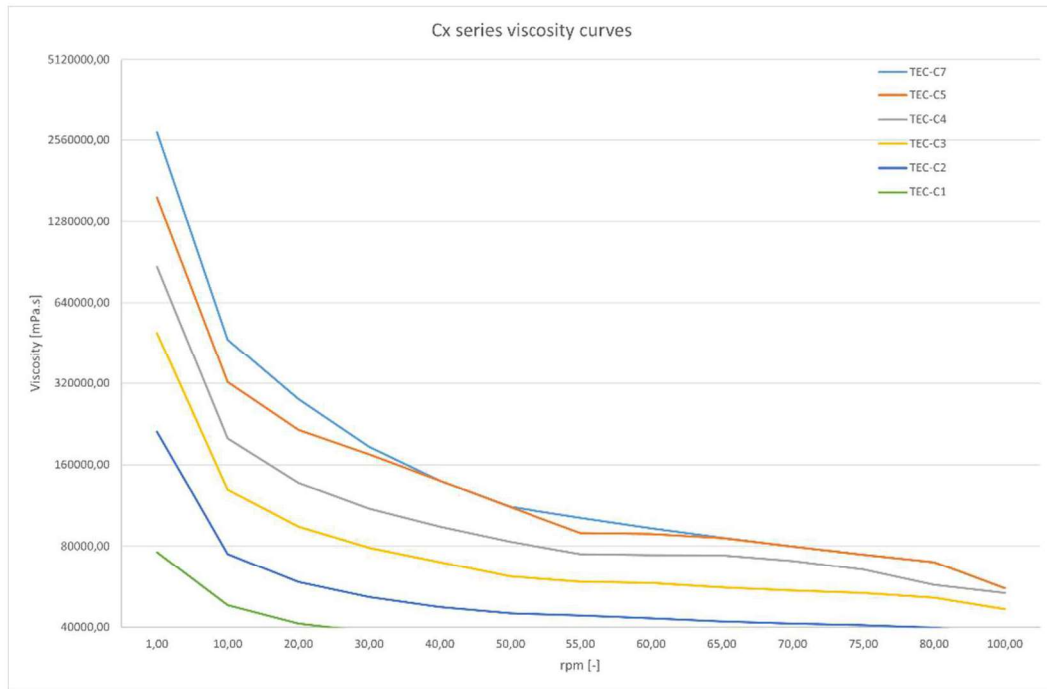
Fig. 1. Viscosity test results for Cx series.

In order to narrow down the number of products to use in the research, a preliminary hydrophobicity test was carried out. Various types of epoxy resins and hardeners were placed in a container with water and mixed to observe their degree of immiscibility in water. The most immiscible samples, i.e., those that separated most rapidly from the water in a separate layer, keeping it clear, were subjected to further testing. This behavior ensures that mixed will not be dissolved to the environment when applied on the protected cultural heritage. Secondly, the selected epoxy resin and hardener were modified by thixotropic agents to improve rheological properties that suits underwater application. The aim of this modification was to find out the products with a pseudoplastic behavior. This behavior refers to a type of non-Newtonian fluid behavior where the viscosity of a material decreases as the shear rate or deformation rate increases. This means that the material becomes less resistant to flow as the applied force or stress increases. This character of resin ensures easy application on the sample and eliminates wash-out to the environment when the coating is applied. The C7 sample from Cx series modified with thixotropic agent, appeared to be the most suitable product (Fig. 1).

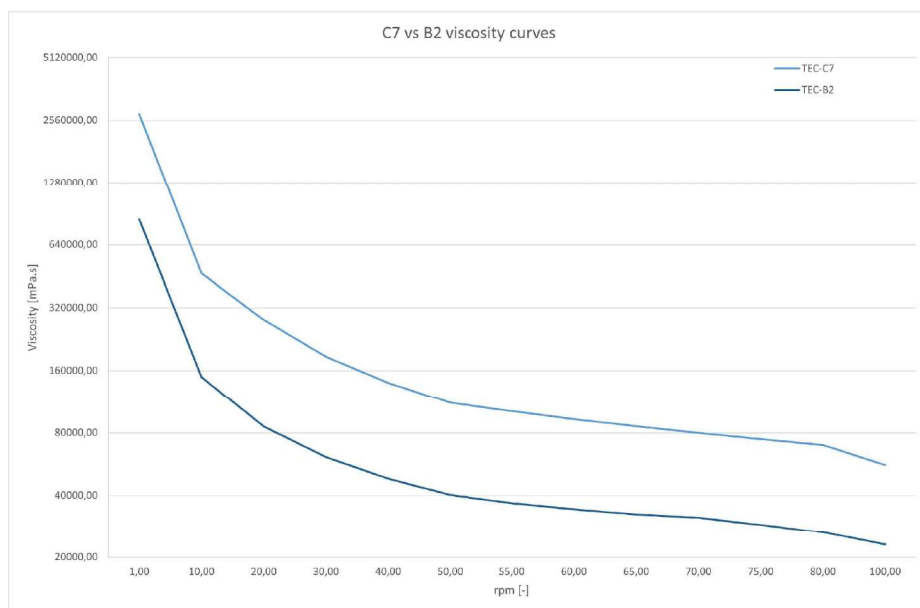
Fig. 2. C7 vs B2 viscosity curves.

Hardener (B2) was chosen such that its viscosity curve was the closest matching one that of the selected resin: a modification of hardener by thixotropic agent (Fig. 2).

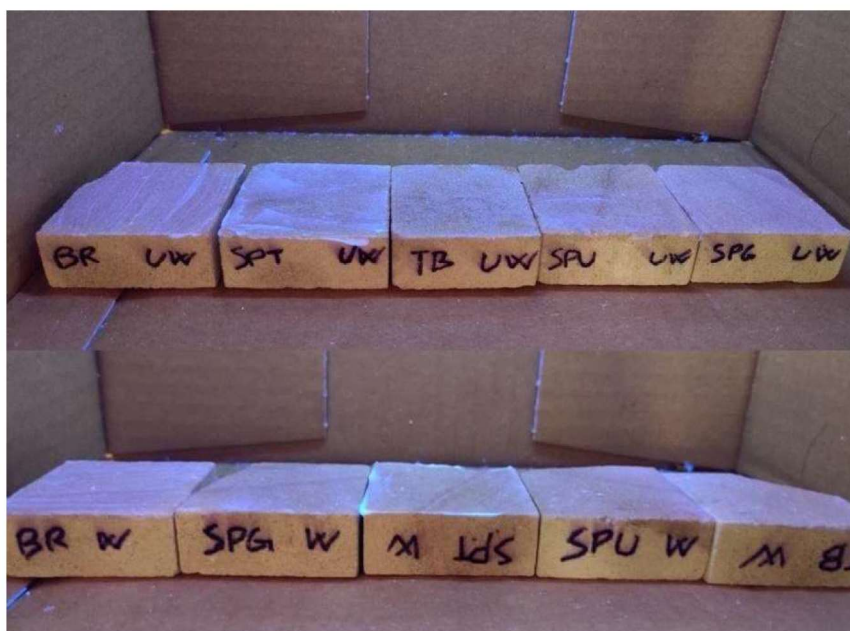
Fig. 3. Different application methods on limestones for C7 product. W=wet samples, on air application; UW=underwater application; BR=brush, SPT=spatula, TB=toothbrush, SPU=PVA sponge, SPG=sponge.

The underwater applicability tests focused on several aspects: possible dispersion of the product during application, ease of application depending on the tool used, and hardening of the product. The results confirmed what had previously emerged from the viscosity tests: C7 sample showed the best applicability in the underwater environment, using soft brushes and/or sponges (Fig. 3), even though issues with short pot life of the mixed product (resin + hardener) emerged.
